# SERVICE BULLETIN

TR-7800, TR-7850

#860

SUBJECT: Memory Channel 7 Indicator Erratic

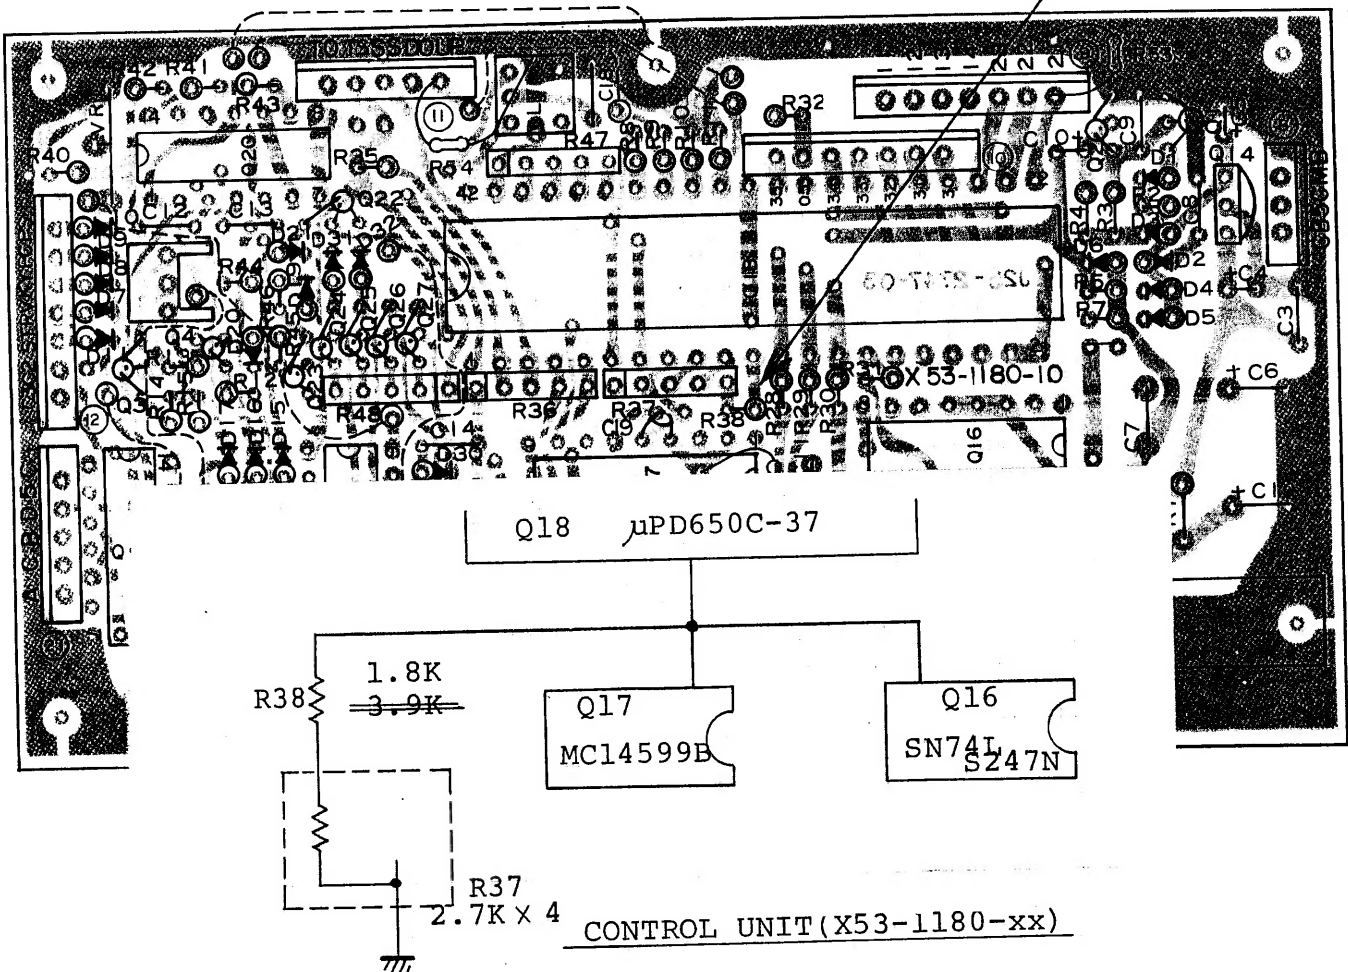
▼ CONTROL UNIT (X53-1180-XX) XX: 10(K), 61(W)(T)

When Memory Channel 7 is selected, the LED may fail to indicate the number 7, although frequency is correctly recalled and all other operations are normal. Cause is incorrect voltage level at Q16 & Q17, and is related to individual differences between these IC's. Correction is by changing one resistor value on the Control unit.

On the Control unit X53-1180-xx, replace R38 from 3.9k $\Omega$  to a 1.8k $\Omega$  resistor (RD14CB2E182J). No adjustments are required.

~~3.9K~~  $\rightarrow$  1.8K
